# Pioneer

## Service Manual

# BDP-LX55

## BDP-53FD

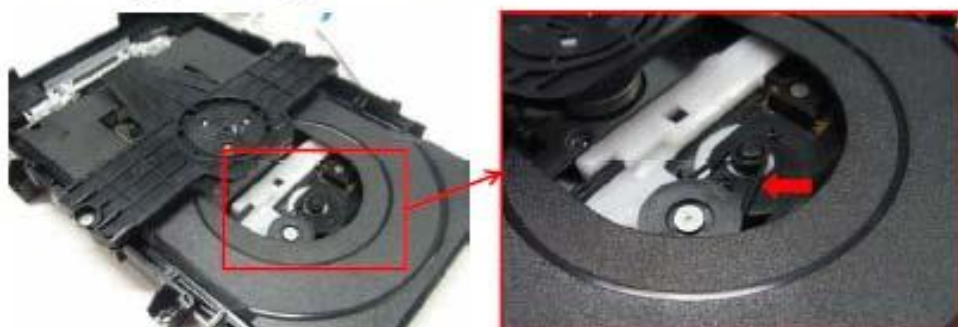
| MODEL No. | * SER. No | S/M No. | PG |
|---|---|---|---|
| SYMPTOM | Can't open the disc tray. | | |
| CAUSE | Due to loading rubber belt deteriorated. | | |

**SYMPTOM**

Although the **loading motor sound is heard** after pressing OPEN/CLOSE button, the **disc tray does not open** due to the loading belt slipping.  
For the above symptom, the loading rubber belt has been available.

| MODEL No. | * SER. No | S/M No. | PG |
|---|---|---|---|
| SERVICE REMEDY | Replace the loading rubber belt. | | |

| + | CURRENT PARTS | | CO<br>DE | NEW PARTS | |
| | SYMBOL/DESCRIPTION | PART NUMBER | | PART NUMBER | SYMBOL/DESCRIPTION |
| A | | | ✓ | 59-968030-000-TL | BELT |
| B | | | | 59-108150-000-TL | BELT |
